Flood Control Project Maintenance
2010 Structure Summary Report
Overall Unit and Item Ratings

City of Sacramento

El Camino Avenue Bridge

Flood Control Project Maintenance**Unit Cover Sheet****2010 Structure Inspection Results****City of Sacramento**

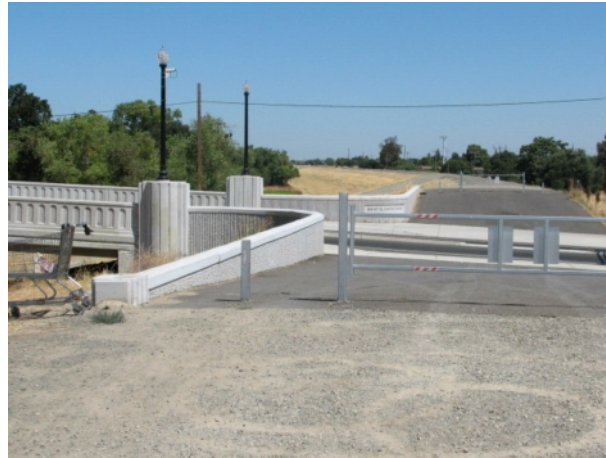
Levee Mile Report Line	1
Start Levee Mile	
End Levee Mile	
Location	
Category	Structures
Item	Photo Documentation
West El Camino bridge crossing Natomas East Main Drainage Canal	
jpaasch_t_20100812_053.jpg

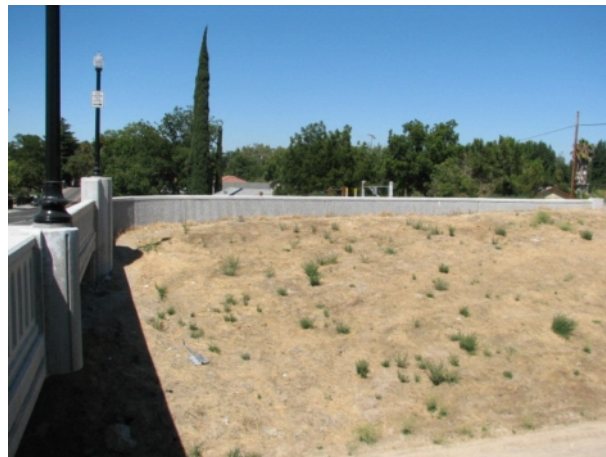
Levee Mile Report Line	1
Start Levee Mile	
End Levee Mile	
Location	
Category	Structures
Item	Photo Documentation
Floodwall at north west end.	
jpaasch_t_20100812_062.jpg

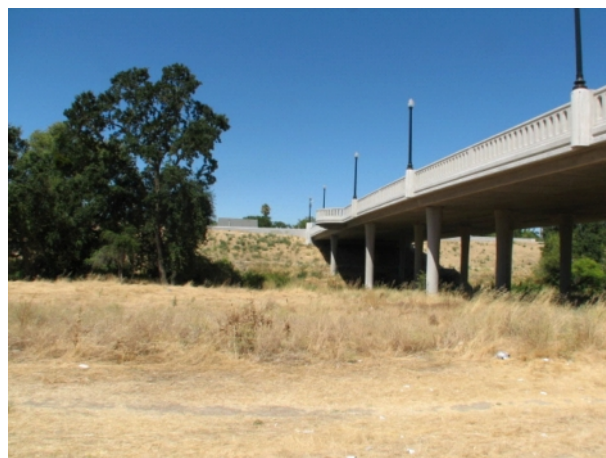
Levee Mile Report Line	2
Start Levee Mile	0.00
End Levee Mile	0.00
Location	
Category	Structures
Item	Vegetation & Obstructions
Structure is free of obstructive vegetation.	
jpaasch_t_20100812_054.jpg

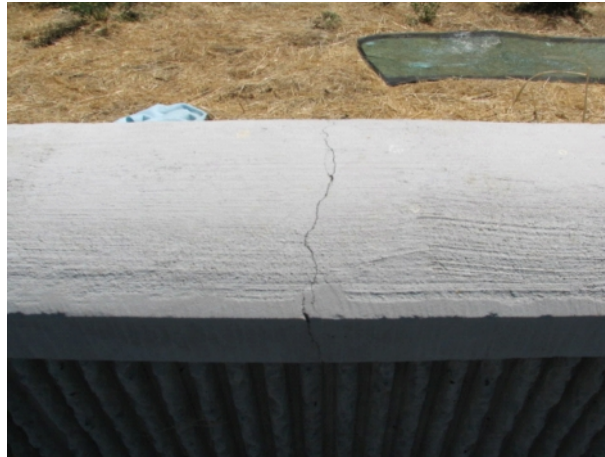
LMR No.	Levee Mile		Category	Item	Location	Rating	Action/Comment	GPS Latitude/Longitude		Photo	Issue No.
	Start	End						Start	End		
15	0.00	0.00	Structures	Concrete Surfaces		A	Inspector Comments: Negligible spalling, scaling or cracking.	38.611365 ° -121.466557 °	38.611365 ° -121.466557 °	Y	15
16	0.00	0.00	Structures	Concrete Tilting / Settlement		A	Inspector Comments: There are no significant areas of tilting, sliding or settlement that would endanger the integrity of the project.	38.611365 ° -121.466557 °	38.611365 ° -121.466557 °	Y	16
17	0.00	0.00	Structures	Concrete Foundations		M	Inspector Comments: Minor scouring around the piers and near the abutment on western abutment.	38.611365 ° -121.466557 °	38.611365 ° -121.466557 °	Y	17
18	0.00	0.00	Structures	Security Fencing		N		38.611365 ° -121.466557 °	38.611365 ° -121.466557 °		18
19	0.00	0.00	Structures	Closure Structures		N		38.611365 ° -121.466557 °	38.611365 ° -121.466557 °		19

Levee Mile Report Line	15
Start Levee Mile	0.00
End Levee Mile	0.00
Location	
Category	Structures
Item	Concrete Surfaces
Hairline cracks on concrete floodwall surface.	
jpaasch_t_20100812_055.jpg

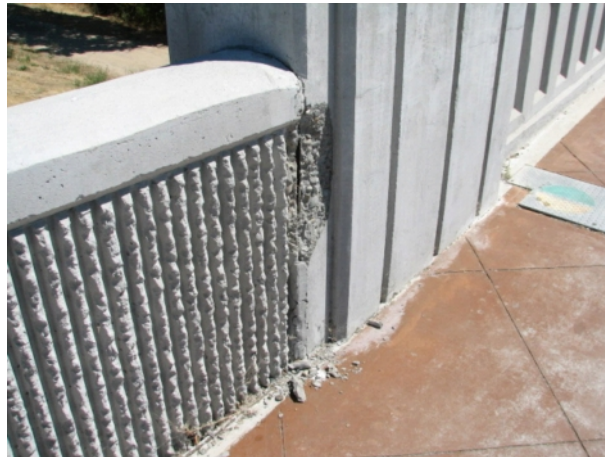
Levee Mile Report Line	15
Start Levee Mile	0.00
End Levee Mile	0.00
Location	
Category	Structures
Item	Concrete Surfaces
Concrete surface damage does not effect structure reliability.	
jpaasch_t_20100812_056.jpg

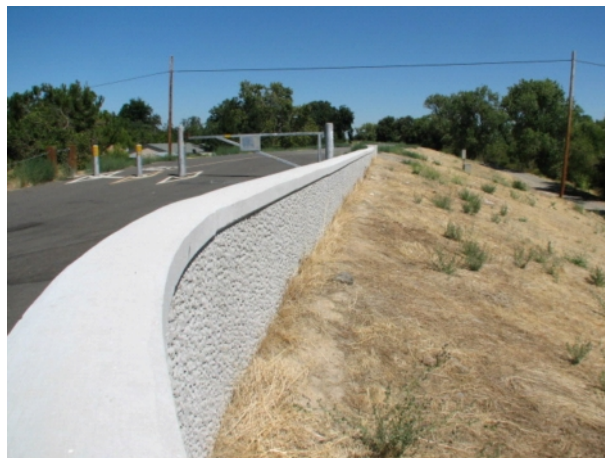
Levee Mile Report Line	16
Start Levee Mile	0.00
End Levee Mile	0.00
Location	
Category	Structures
Item	Concrete Tilting / Settlement
Flood wall at north west end remains in place.	
jpaasch_t_20100812_059.jpg

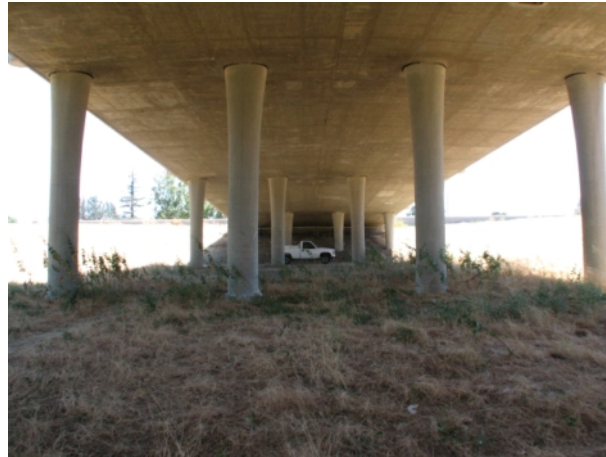
Levee Mile Report Line	17
Start Levee Mile	0.00
End Levee Mile	0.00
Location	
Category	Structures
Item	Concrete Foundations
Photo of concrete piers and abutment.	
jpaasch_t_20100812_057.jpg

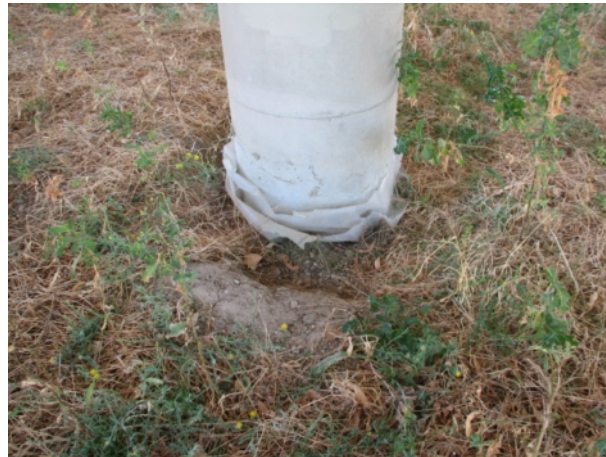
Levee Mile Report Line	17
Start Levee Mile	0.00
End Levee Mile	0.00
Location	
Category	Structures
Item	Concrete Foundations
Photo of pier footing.	
jpaasch_t_20100812_058.jpg

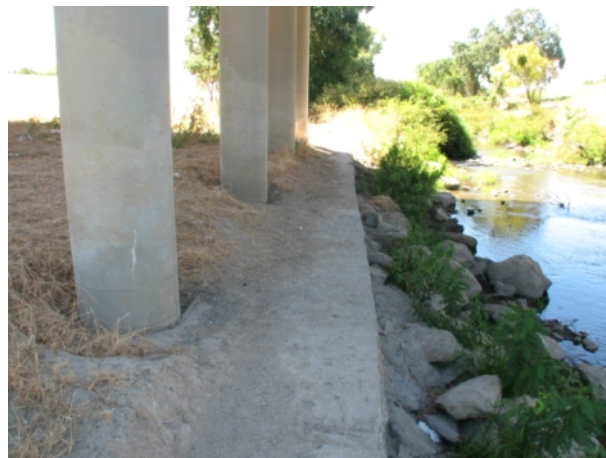
Levee Mile Report Line	17
Start Levee Mile	0.00
End Levee Mile	0.00
Location	
Category	Structures
Item	Concrete Foundations
Concrete foundation in good condition.	
jpaasch_t_20100812_061.jpg
